FM 121 Rehabilitation S Curve Realignment, Grayson County, Texas

Report for Archeological Survey

Paris District

Texas Antiquities Permit No. 7164

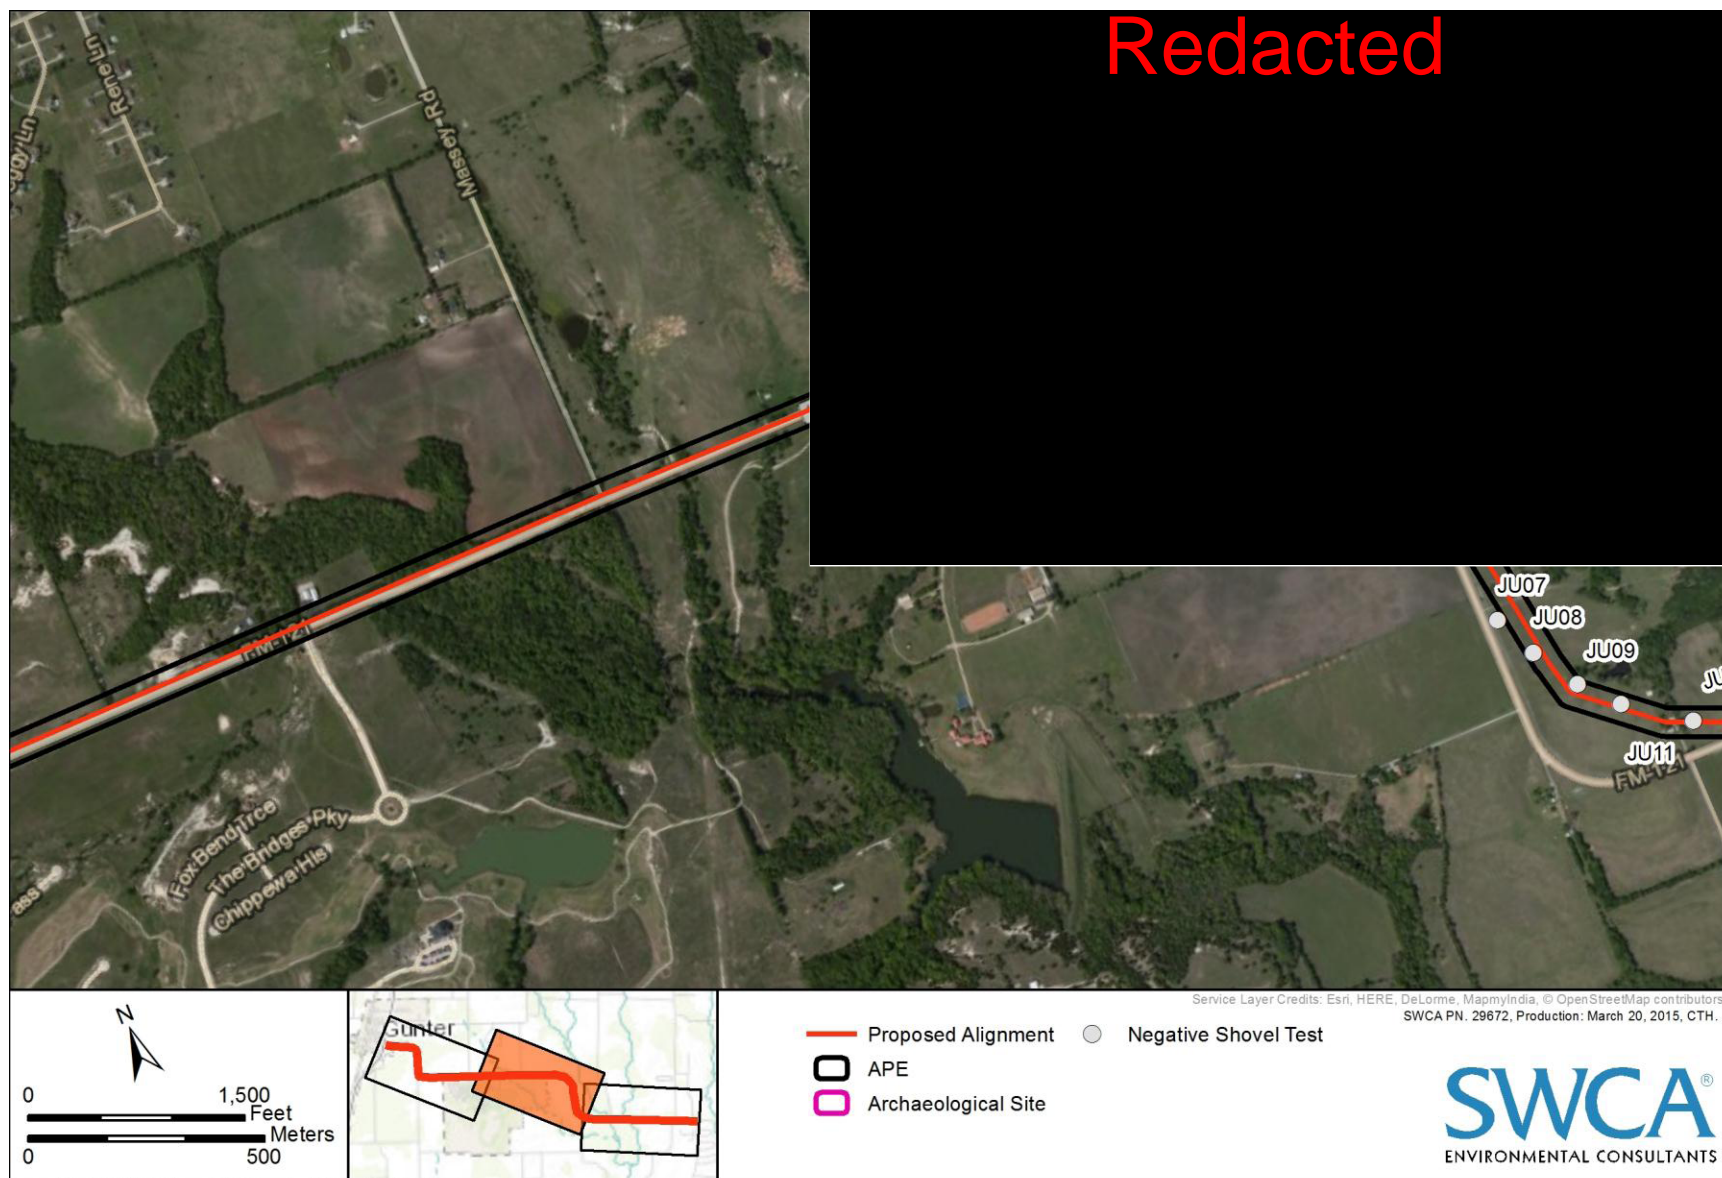
Figure 8a. Survey results, western segment.

Figure 8b. Survey results, central segment.

Figure 8c. Survey results, eastern segment.

- **Surveyors:** Ken Lawrence, Jessica Ulmer, and Jared Wiersema.
- **Methodological Description:** A pedestrian inspection was conducted across the entire APE, located within the existing TxDOT ROW (Figures 8a–8c). To assess the previously noted potential for deeply buried archaeological sites, backhoe trenching served as the primary method for quickly and efficiently exploring areas and deposits.

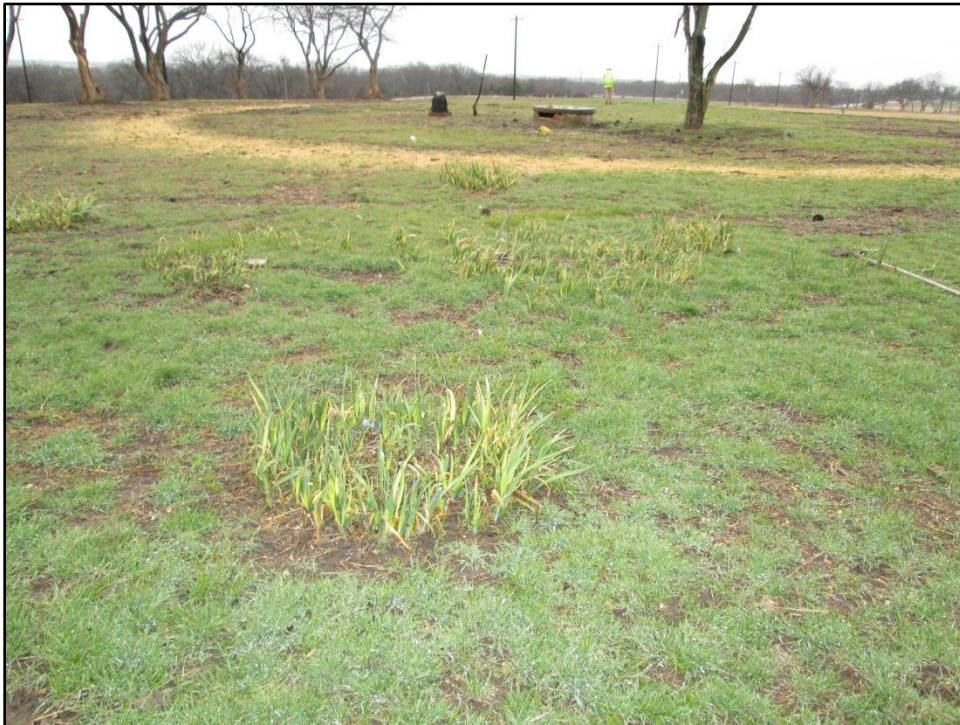
Figure 24. Photo of Feature F2 in foreground, identified as iris patches. Feature F1 is seen in the background (view southeast).

- Redacted
[REDACTED]. It consists of a surficial scatter of historic-age domestic debris and two features (F1 and F2). Due to extensive disturbance at the site, surface visibility was 90–100 percent. Two shovel tests (JU05 and JU06) were placed in the midst of the site to determine vertical extent of the cultural materials (see Table 2). Both of these excavations were negative and encountered degrading limestone bedrock and compact soils at 30 cmbs. The artifact assemblage (glass, metal, ceramic, and plastic) is severely disturbed and heavily fragmented with no artifacts greater than 3 inches (7 cm) in size observed. The glass artifacts (clear, blue, amethyst, and green colored) were exclusively from bottles, mostly beverage with two patent medicine containers (Figures 22 and 23). The metal fragments were all corroded and appeared to be a mix of machine parts and hinges. The ceramics were predominantly whiteware fragments with no makers' marks and one thick (0.5 inch [1.25 cm] thick) brown sherd with a dark brown glaze and coarse matrix. The plastic artifacts consist of clear beverage bottle detritus and assorted unidentifiable pieces. The temporally diagnostic artifacts for 41GS246 are limited to the glass category. Based upon manufacturing techniques, a portion of the glass assemblage (i.e., amethyst glass and several bottle finishes) date to the early twentieth century (IMACs 2001). The majority of the site assemblage appears to date to the middle to later twentieth century. Features identified at 41GS246 consist of a capped well or cistern (F1) and an area of ornamental flowers (F2), tentatively identified as irises (Figure 24).

- The second feature, F2, solely consists of small clusters of ornamental flowers, believed to be irises, scattered over a roughly 5 m diameter area (see Figure 24). Although considered, these were not interpreted as possible gravesite locations. First, there was no distinct mounding, depression, or soil discoloration around the cluster of plants. Conversely, there was a soil discoloration and presence of degraded limestone bedrock in the vicinity of the F2 well/cistern feature that suggested deep excavation into the substrate. Secondly, the area features a very shallow limestone substrate (generally encountered at a maximum of approx. 2 feet / 60 cm below the present ground surface), as was determined by the shovel tests (in the APE and on the site) and observed in a nearby ditch exposure. The shallow substrate would have been a deterrent to placing interments in this locality. Finally, the 1936 General Highway Map of Grayson County and 1962 Gunter USGS Topographic Quadrangle depict the Elliot Cemetery

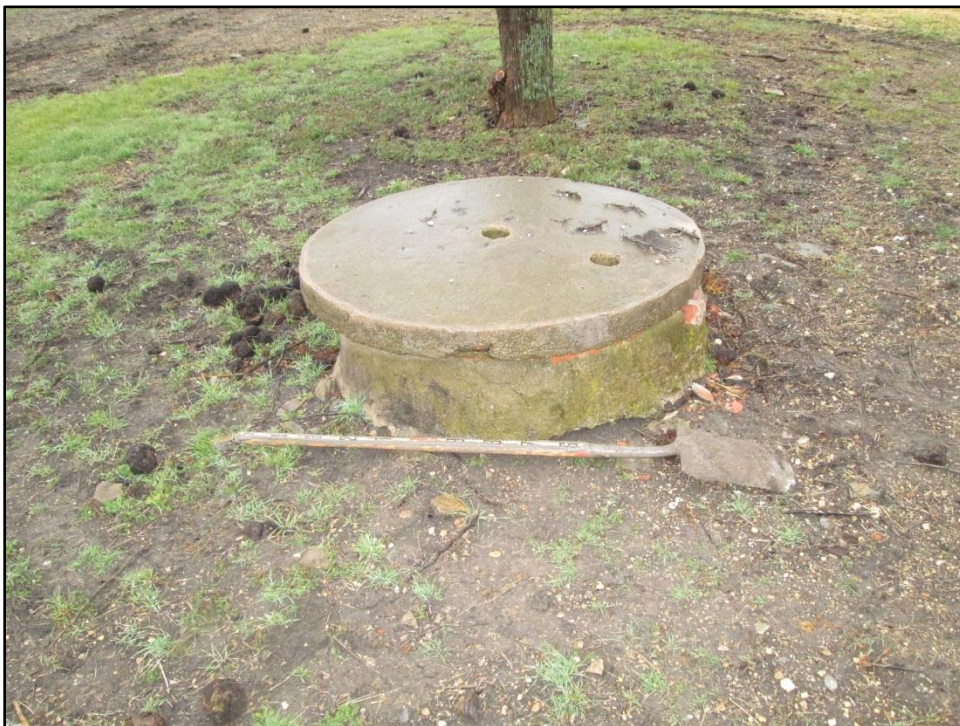
Figure 25. Photo of Feature F1 (view west). The structure represents either a well or cistern, and the concrete cover may have been a later addition.

- The well/cistern (F1) is roughly 3 feet (90 cm) in diameter, extends about 2 feet (60 cm) above the ground surface, has a red brick interior faced with concrete, and is capped by a 3-inch-thick (7-cm-thick) circular slab of concrete (Figure 25). The concrete lid had two holes bored through it, which may have functioned as intake and extraction points. If accurate, a cistern seems more likely as a pump would have been fit over the first of the holes for water extraction, while a feeder pipe would have deposited water into the chamber through the second. The concrete cap was too heavy to remove manually, so the internal architecture of the structure could not be verified. No inscription or other temporal informative elements were present on the feature, but it likely dates to the original early 20th-century construction period for the now absent structure.
